**FOR THE MEETING OF: July 15, 2021**  
**AGENDA ITEM: 5.a**

**CASE NO.:** Historic Design Review Case No. HIS21-13

**APPLICATION SUMMARY:** A proposal to replace the window glazing and install window security film, replace doors and terracotta on the exterior of the Oregon Justice Building.

**LOCATION:** 1162 Court Street NE

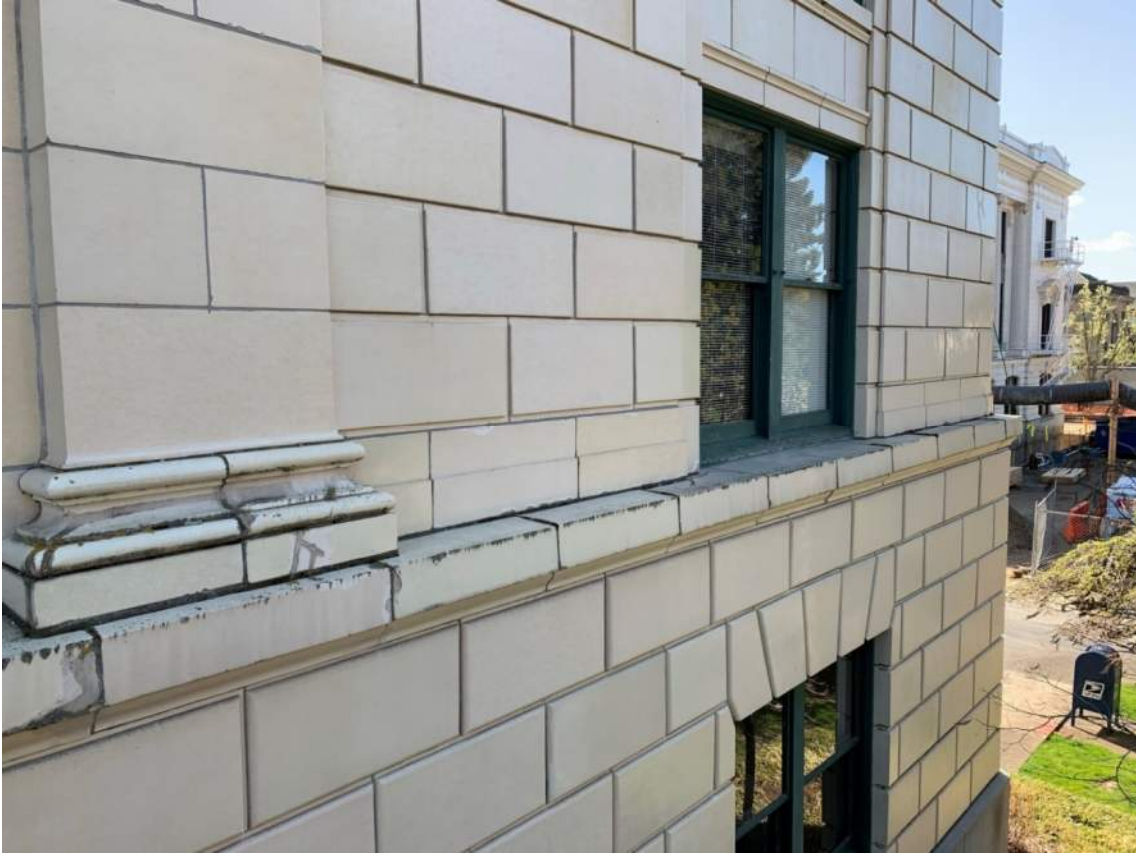
*Figure 4 - Terracotta - Existing Conditions*

The applicant is proposing to replace small sections (estimated 5 to 20) of terra cotta on the exterior façade of the Justice Building with Glass Fiber Reinforced Concrete (GFRC) replica pieces. The applicant is proposing to repair terra cotta with in kind material whenever feasible, however where the cracks are too deep to repair, GFRC will be utilized. This material has been utilized on other significant historic resources including the adjacent Oregon Supreme Court building. The applicant is proposing to mockup a color/glaze prior to fabrication in order to ensure that the replacement pieces will match the existing to the greatest degree feasible. Staff recommends that the HLC find that Guideline 230.065 (b) has been met.

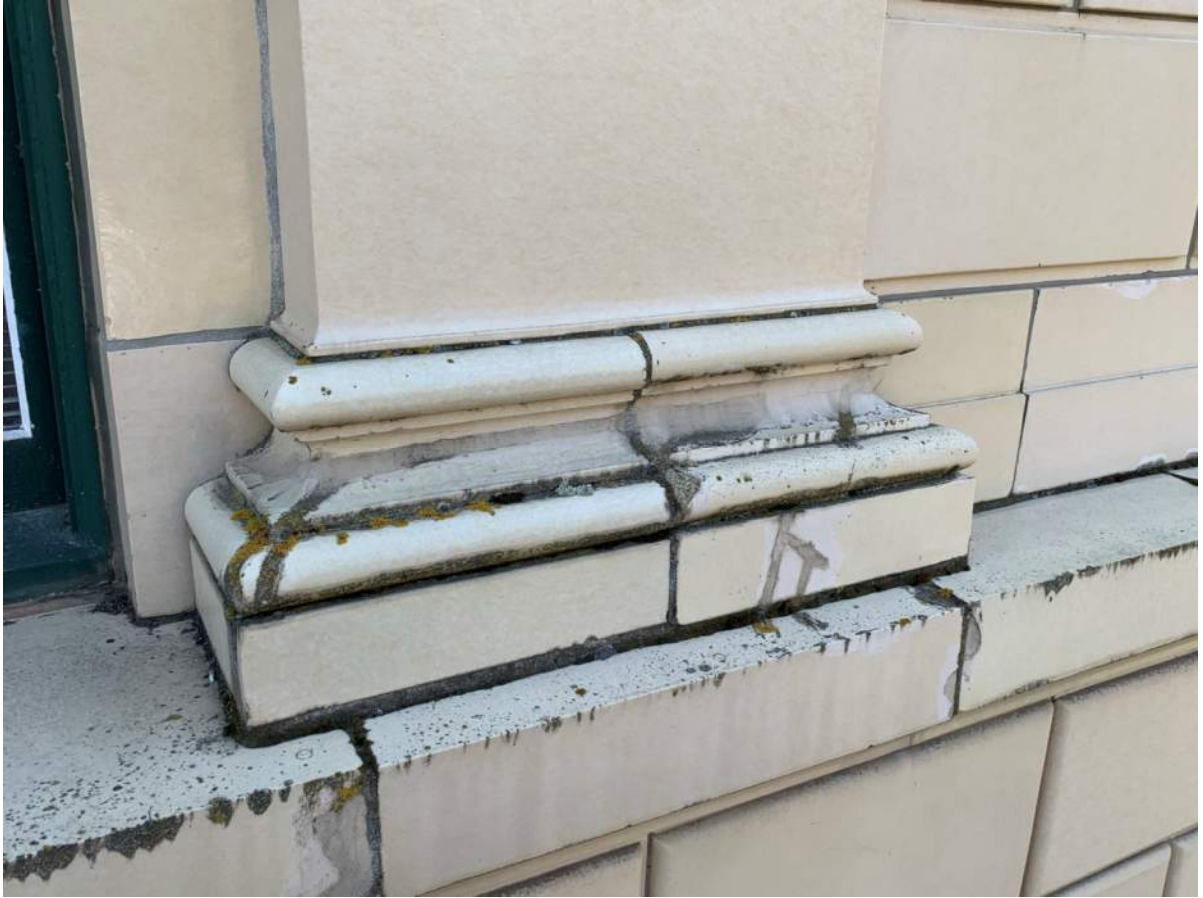
*Figure 5 - Terracotta - Existing Conditions*

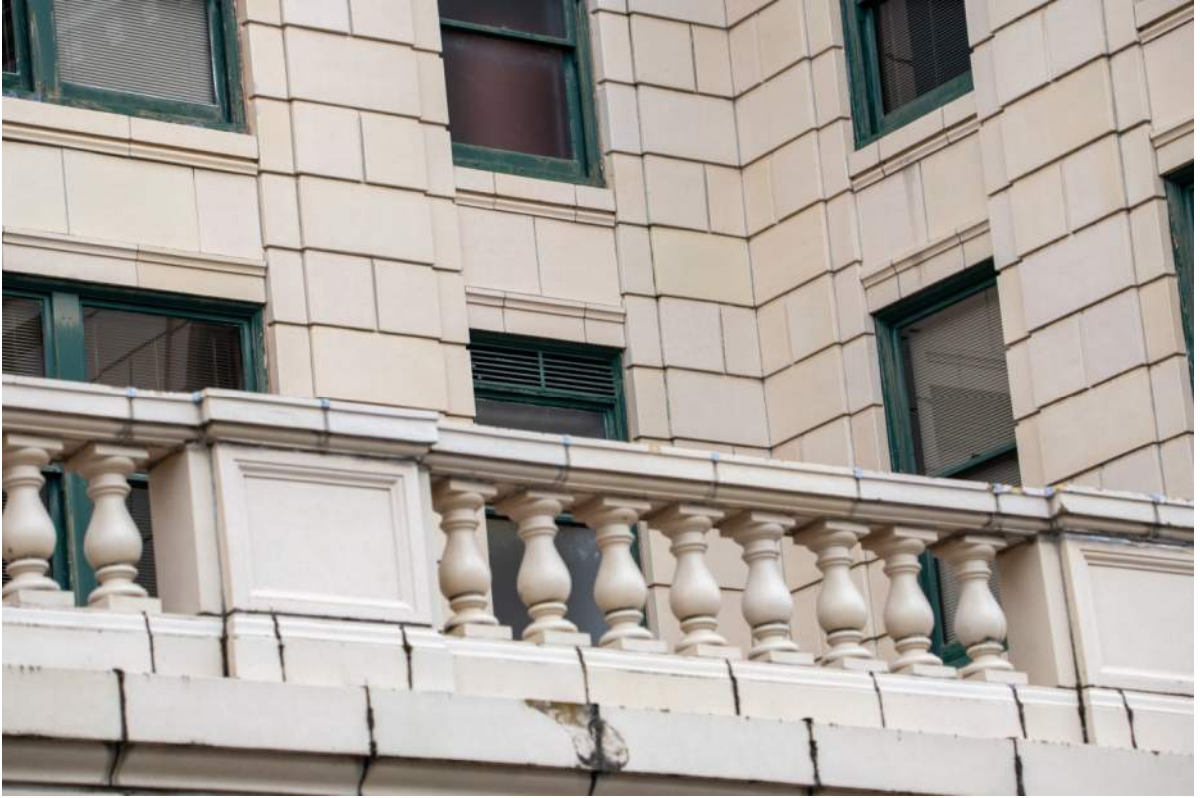
*Figure 6 - Terracotta - Existing Conditions*

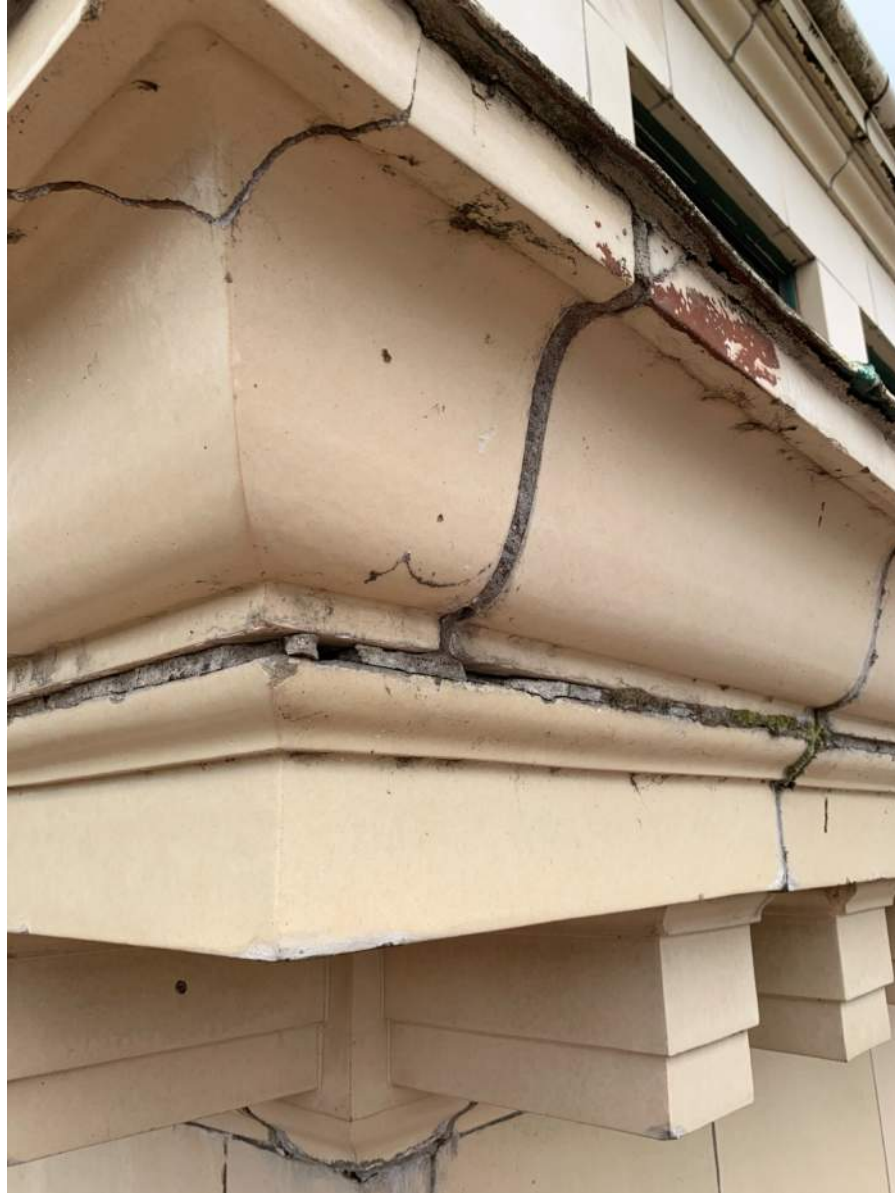
*Figure 7 - Terracotta - Existing Conditions at Cornice*

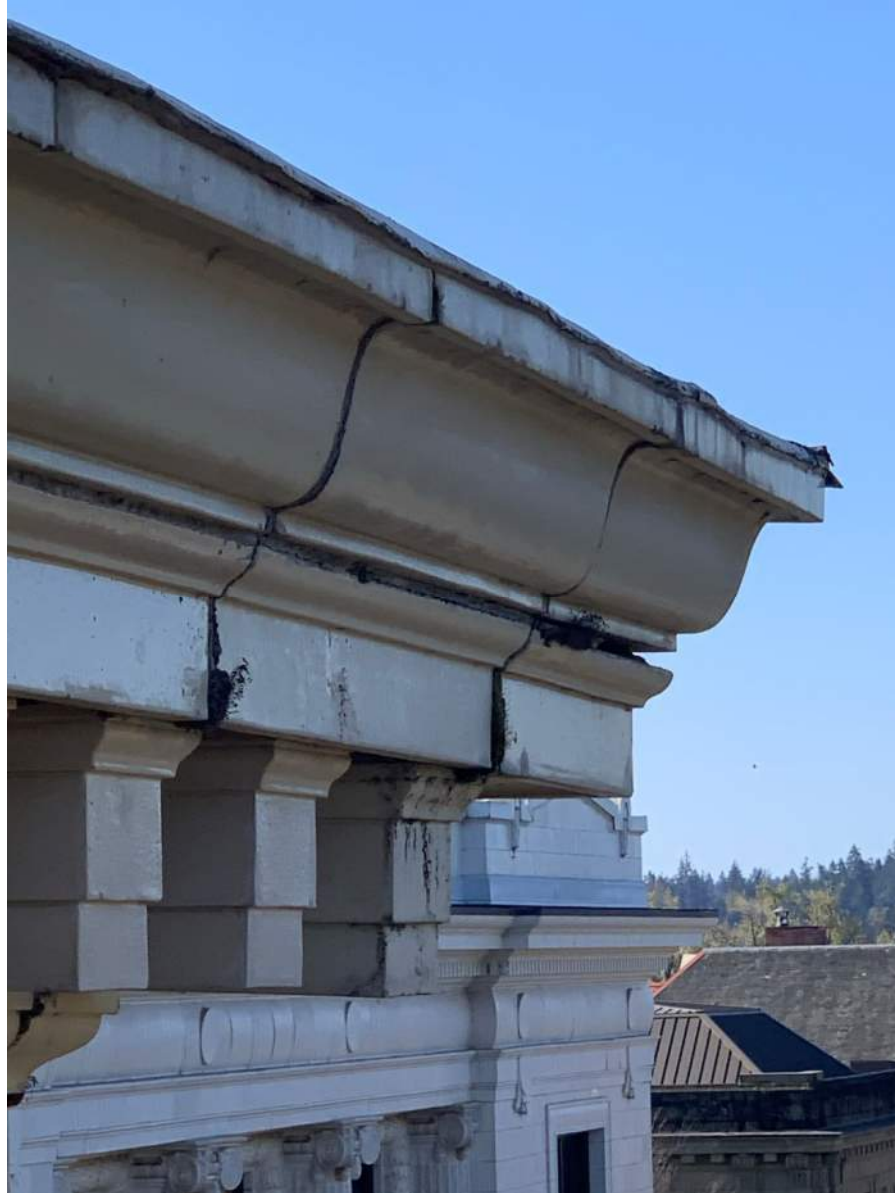
*Figure 8 - Terracotta - Existing Conditions - Cornice*

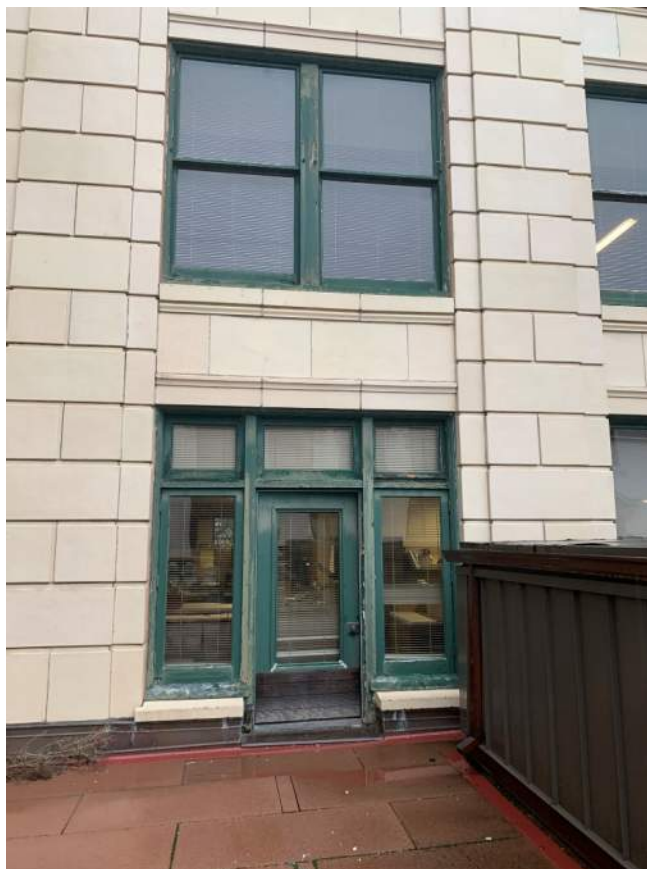
The applicant is proposing replacement of two deteriorated wooden entry doors on the south façade. It is not feasible to repair these doors due to the level of deterioration. While the applicant is proposing to utilize a different type of glazing (double paned IGU's), this change is minimal. Overall, the proposed new doors generally match the existing in material and design.

*Figure 18- Wood door at light court on the South elevation*

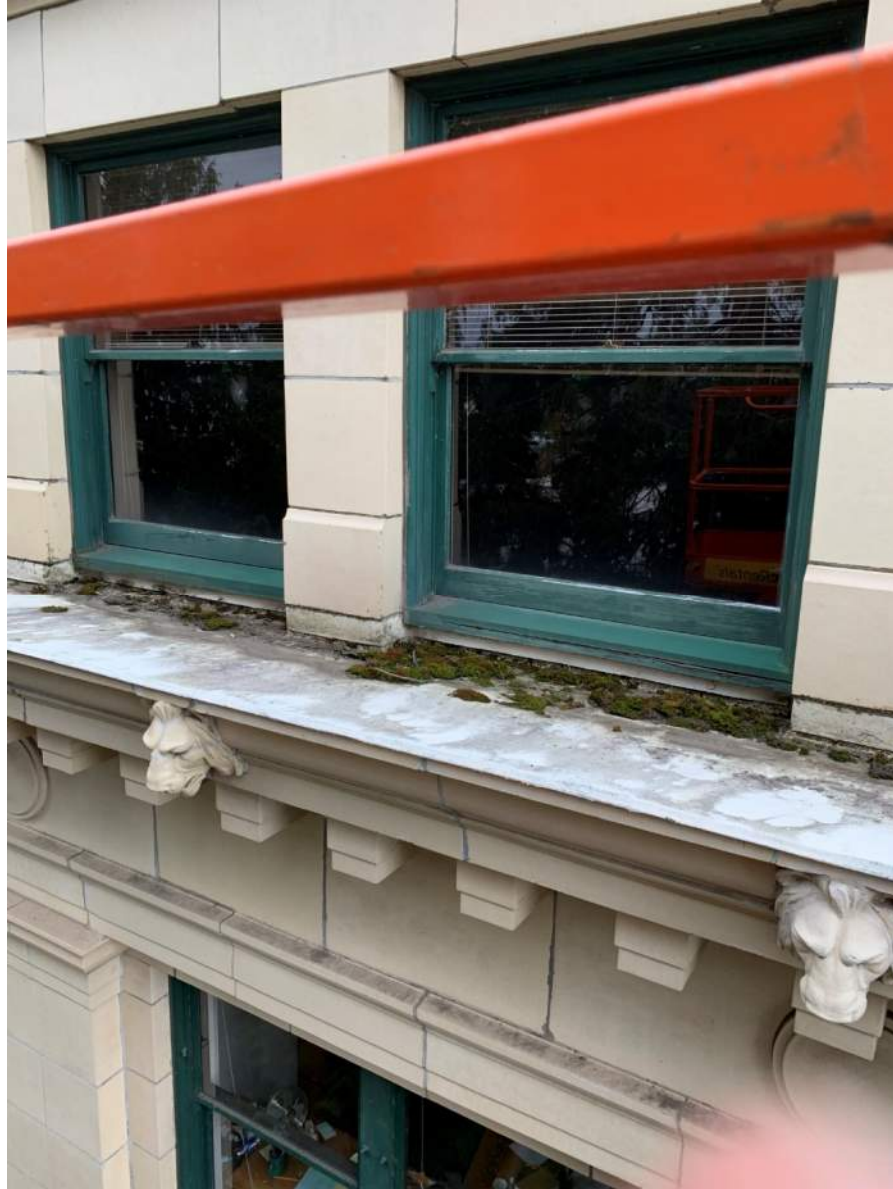
Raising the sill will prevent long term damage that has been occurring to window sills at this level due to continued contact with water that pools on the cornice during heavy rain.

*Copper sill pan flashing(painted white) below the wood sill under North façade 5<sup>th</sup> floor window. Distance from sill pan varies from left to right as the roof slopes.*

The proposed raising of the windowsills at the fifth floor will require shortening the length of the lower sash on each window. This change is minimal, as the sills need to be raised just 2" in order to address design flaws related to inadequate drainage.
