# Pedestrian Safety Study

March 2018

## FINAL REPORT

City of Salem  
Public Works Department

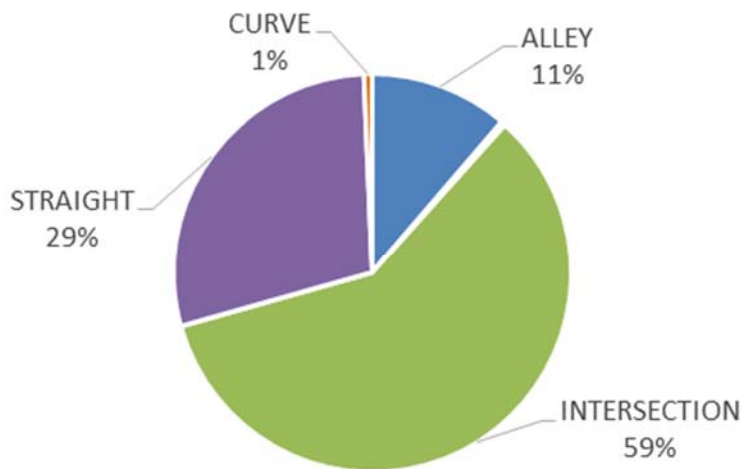
**Figure 2: Percentage of Crashes (2011-2016) by Roadway Character**

As shown in Figure 2, nearly 60% of the reported crashes occurred at intersections, with another 29% occurring on straight roadway segments and 11% occurring at alleys or driveways. Of the crashes that occurred at intersections, nearly 67% occurred at a signalized intersection.

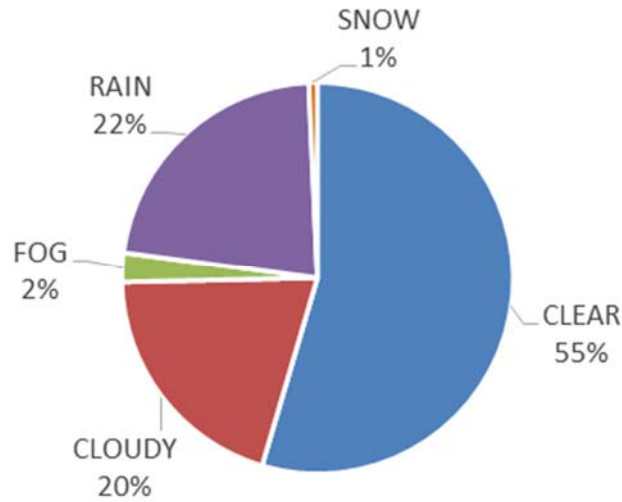
**Figure 3. Percentage of Crashes (2011-2016) by Weather Conditions**

The proportion of crashes occurring during different weather conditions is shown on Figure 3 on the following page. As shown, 75% of the reported crashes occurred during clear or cloudy conditions, and 22% occurred during rain events. Although more rain-related events might be expected due to the climate in Salem, the percentages are representative of typical pedestrian activity levels for weather conditions (fewer people travel by foot during inclement weather).

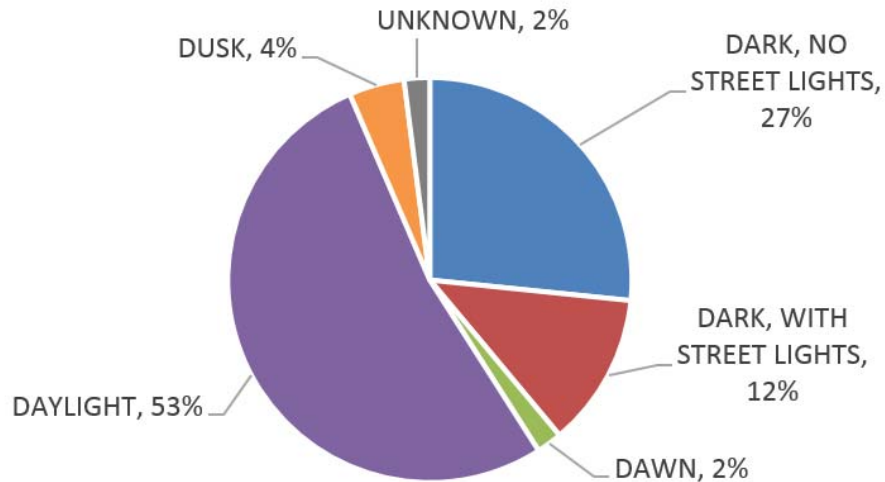
**Figure 5: Percentage of Crashes (2011-2016) by Lighting Condition**

While time of day is an important consideration, the reported lighting conditions can provide further insight since daylight hours shift throughout the year. As shown on Figure 5, 53% of crashes occurred during daylight hours, while 39% occurred in the dark (both with and without street lighting).

Although only 39% of all crashes occurred in the dark (Figure 5), this proportion jumps to over 80% when looking only at fatal crashes. In fact, the percentage of crashes occurring at night (particularly when no street lights are present) increases steadily as crash severity increases. In other words, fatal and severe pedestrian crashes are more likely to occur in the dark than during daylight hours.

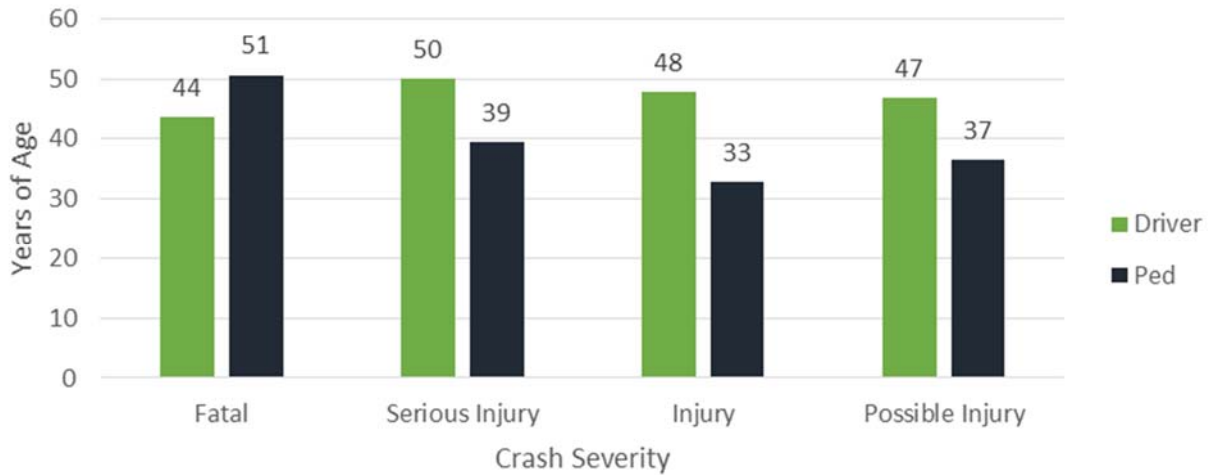
**Figure 6: Average Age of Crash Participants by Severity (2011-2016)**

Figure 6 and Figure 7 on the following page depict the demographic trends for both drivers and pedestrians. The drivers involved in the reported pedestrian-related crashes ranged in age from 16 to 95 years old, with an average age of 47. The pedestrians involved ranged in age from 1 to 90 years old, with an average age of 36. A higher proportion of drivers were male than female (59% to 41%, respectively). Similar to the driver demographics, more pedestrians were male than female (62% to 38%, respectively).

As shown on Figure 6 and Figure 7, the ages and gender of drivers remained relatively consistent across all crash severity levels. However, the average age of pedestrians involved in fatal crashes was significantly higher than other severity levels (51 years old compared to 36 years old). There was also a noticeable increase in the proportion of male pedestrians involved in fatal crashes as compared to other severity levels (73% male/27% female compared to 57% male/42% female).

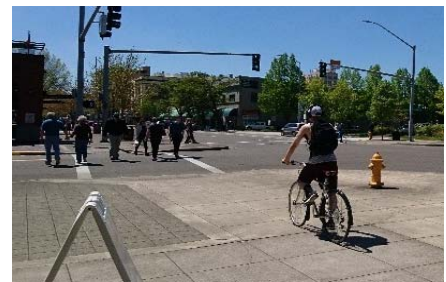
**Pedestrians crossing High Street NE**

Many pedestrians were seen crossing mid-block or crossing against the pedestrian signal. This trend is supported by the crash data that indicates 65% of non-intersection pedestrian crashes involved pedestrians illegally in the roadway.

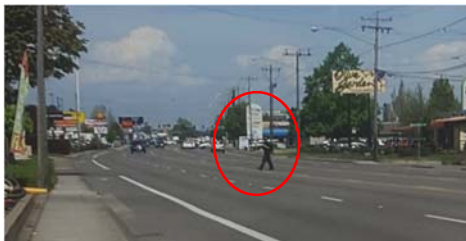
**Pedestrian crossing mid-block on Lancaster Drive**

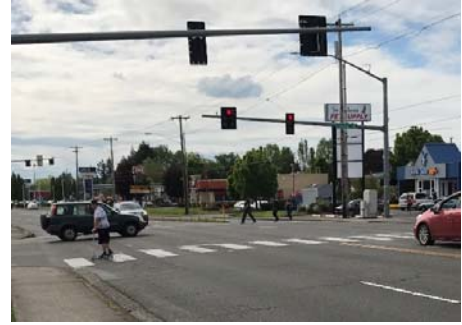
Left-turning vehicle yielding to pedestrians in crosswalk on Market Street

Another common trend was the high number of conflicts that occurred between pedestrians and turning vehicles. Long delays and impatient drivers resulted in aggressive turning movements through crosswalks and created several near-miss situations.
